Water Compliance Inspection Report

**NPDES
Inspection Report**

Rhody Dairy, LLC

February 2, 2011

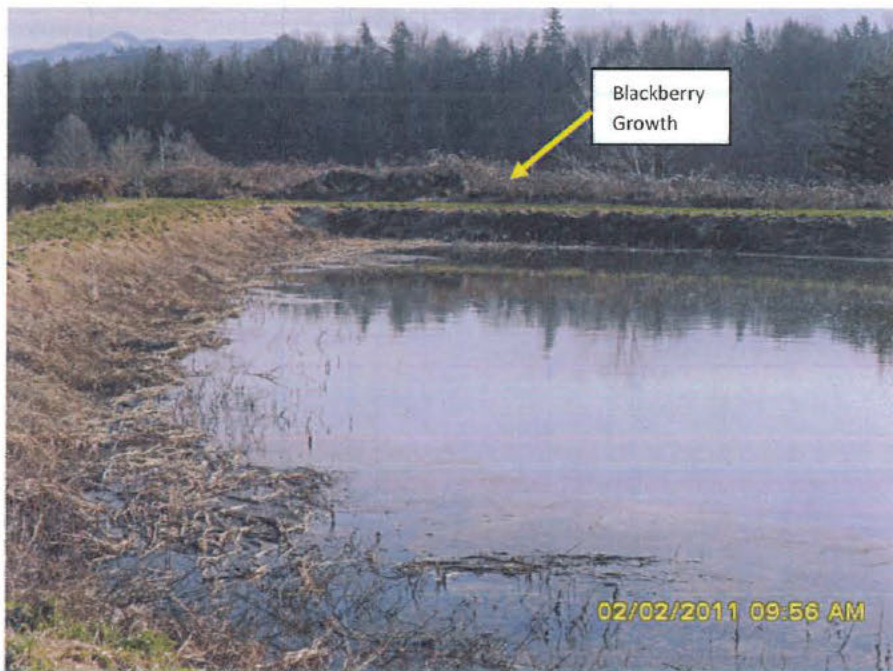
- C. Main Facility Lagoon Maintenance At the time of the inspection of the main facility, I inspected the waste storage lagoon. I saw a significant amount of blackberry growth on the outer east wall of the lagoon which stretched between the side of the lagoon and the Sumas River. See photograph #s 6 to 8 of attachment B for details.

The concern with this blackberry growth is the impact that such growth could have on the integrity of the lagoon. This area of concern was brought to the attention of Mr. DeJong at the time of the inspection.

Photo #6: Easterly view of the lagoon at the main facility. Note the east side of the lagoon in the background. Also note the blackberry growth on the outside of this east lagoon wall.

DAIRYMAN PLANS TO PUMP DOWN/CLEAN OUT LAGOON 2 AND APPLY TO GRASS FIELDS ONCE MORE PRIOR TO THE END OF OCTOBER. LAGOON BANKS LOOK WELL MANAGED, COVERED IN GOOD GRASS COVER. HEAVY BLACKBERRY COVERING EAST OUTERBANK OF LAGOON 1 SHOULD BE REMOVED SO THAT LEAKAGE OR EVIDENCE OF CONDITIONS WHICH COULD LEAD TO LEAKAGE WOULD BE READILY OBSERVABLE.

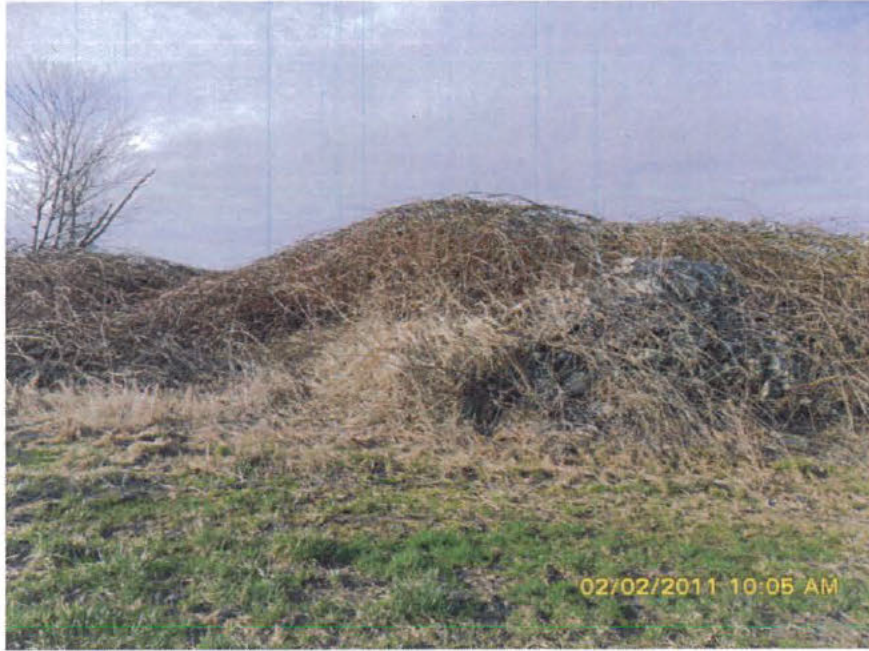
Photo #7: Southwesterly view of the blackberry bushes near the northeast corner of the lagoon at the main facility.

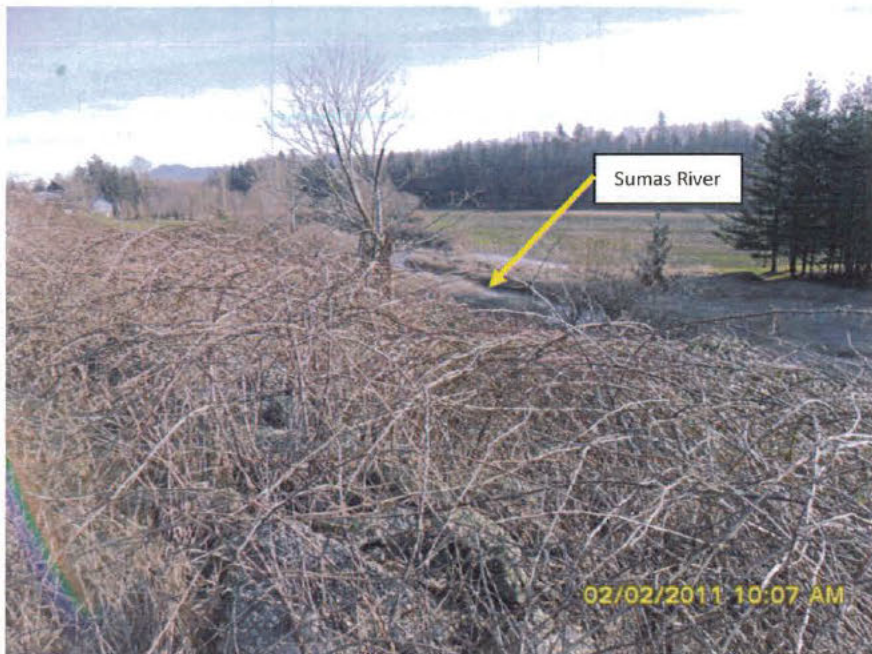
Photo #8: Northeasterly view while standing on the eastern wall of the main facility lagoon. Note the blackberry bushes along the outside of the east lagoon wall. Also note the Sumas River on center.

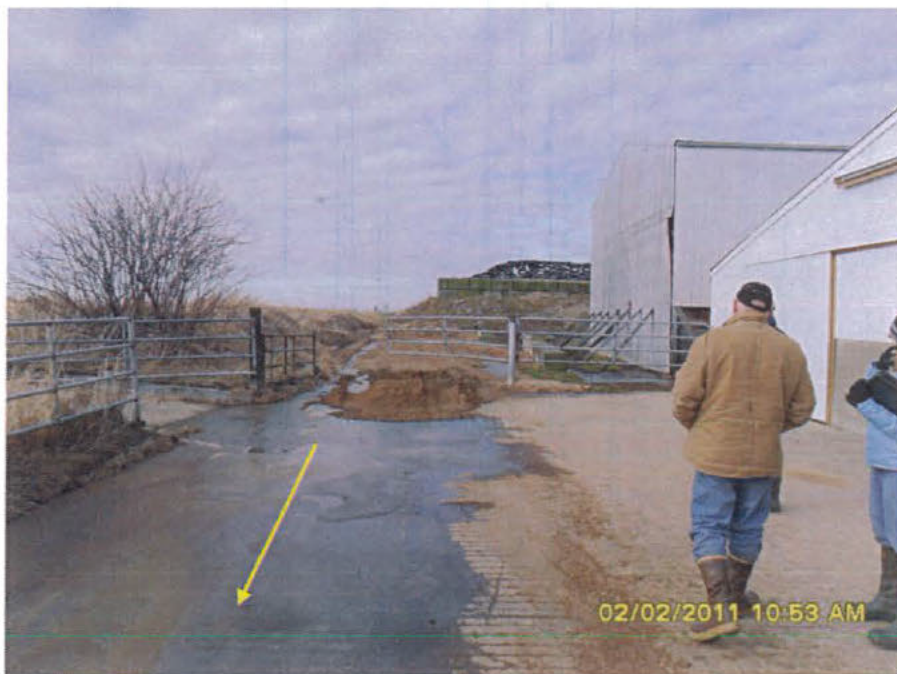
- B. Calf Waste Pile Runoff At the time of the inspection of the calf confinement area, I saw that manure from the calf barn was scraped and piled on an uncovered concrete slab adjacent to the calf confinement barn. There was no discharge from the piled calf waste due to the frozen conditions at the time of the inspection. However, there was no mechanism in place to prevent runoff from this area from flowing off the concrete slab and flowing into a nearby field.

Photo #13: Westerly view showing the piled waste which was scraped from the calf barn.

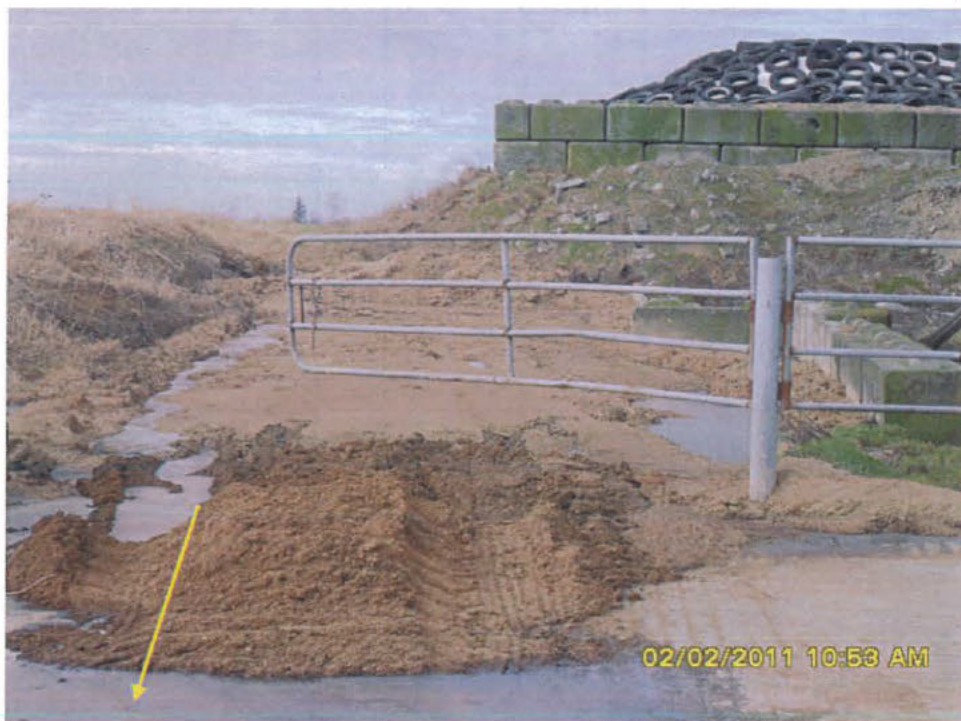
Photo #14: Close-up of the piled calf waste.

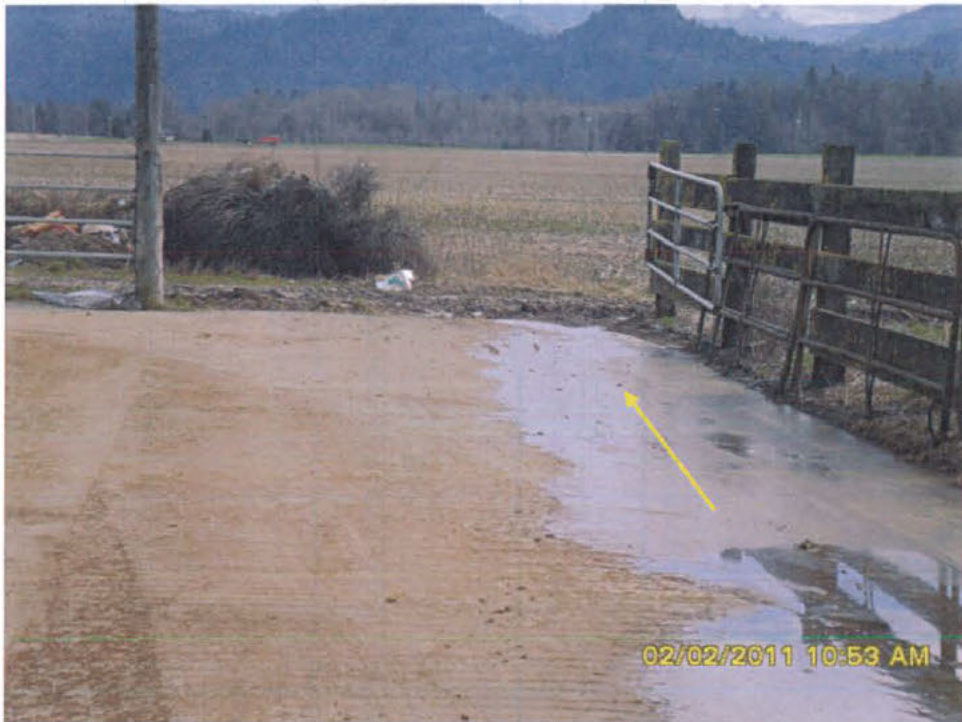
Photo # 15: Easterly view showing the frozen runoff from the piled calf waste. The slope of this concrete slab is down gradient toward the east, away from the waste pile.

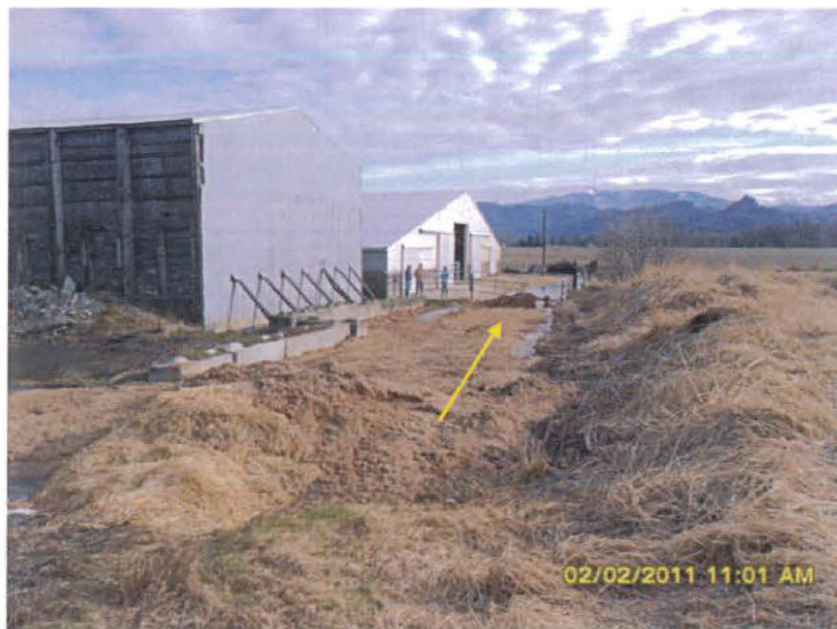
Photo #16: Easterly view showing the piled calf waste on center and the north lagoon wall on the right.

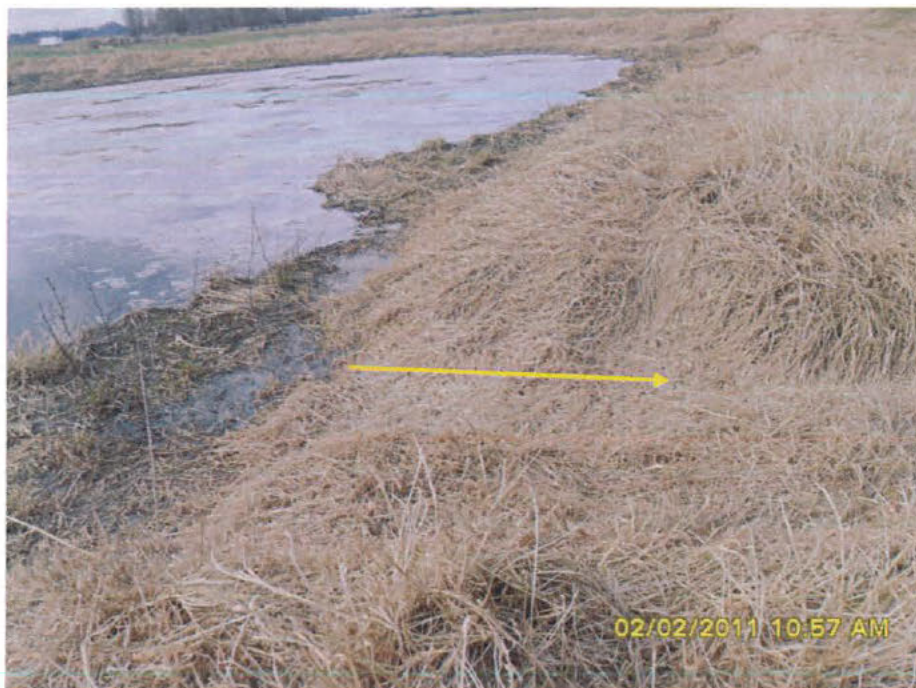
- A. Calf Confinement Area Lagoon Overflow At the time of the inspection of the calf confinement area, I inspected the waste storage lagoon at this location. During the inspection of this lagoon I saw that a notch was cut into the north side of the lagoon. Mr. DeJong estimated that this notch was approximately twelve feet wide and that it lowered the height of the lagoon wall approximately two feet. Mr. DeJong also said that this notch was cut into the lagoon in order to use an agitator to stir the lagoon contents.

During the inspection of this lagoon, I also saw that the water level in the lagoon was at the level of the notch. I did not see an overflow from the area of the notch; however, the lagoon wall in the area of the top of the notch appeared saturated.

Photo # 18: View of a notch cut into the north wall of the calf confinement area lagoon.

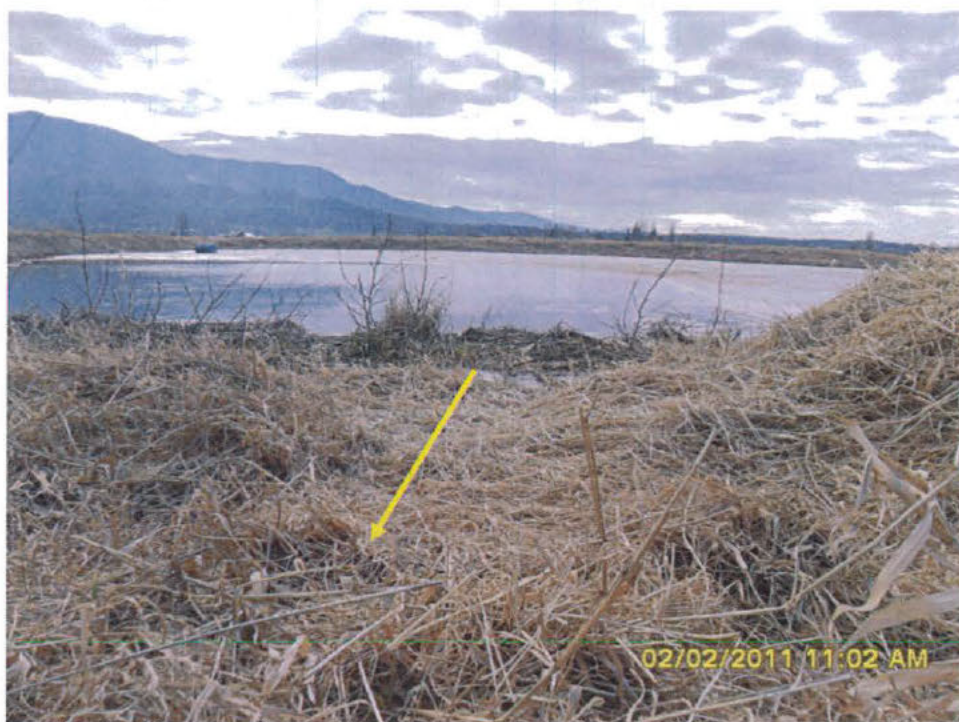
Photo #19: Southerly view into the area of the notch in the calf confinement area lagoon.

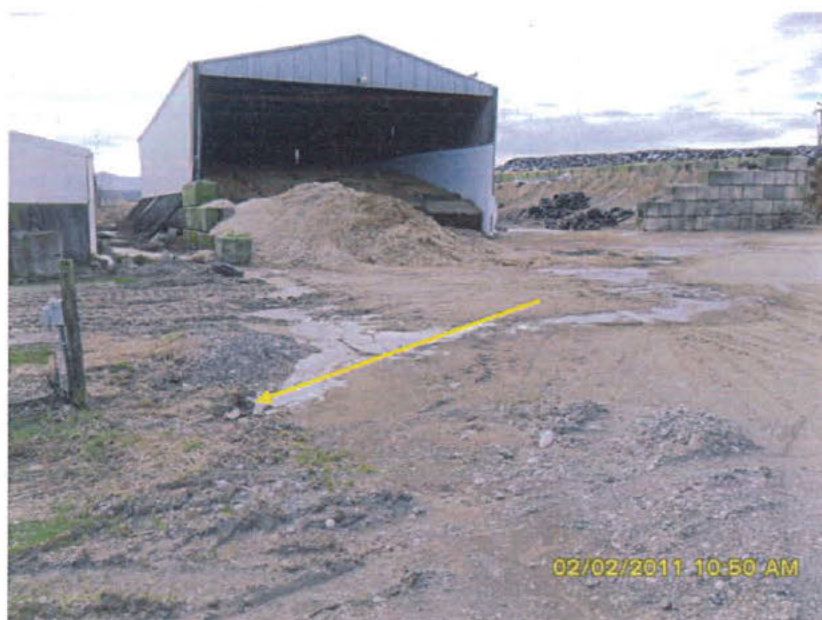
Photo #20: Southerly view showing the silage leachate flowing in the vicinity north of the calf confinement area. This runoff is routed to a drain in the foreground prior to being pumped to the lagoon.
